Recommendations for Preservation of Dirt (Unpaved) Roads in Philipstown, NY

Mr. Terry Zaleski President, Old Road Society of Philipstown Garrison, New York 10524

Ken Skorseth Retired Program Manager, SD Local Transportation Assistance Program SD State University, Brookings, SD

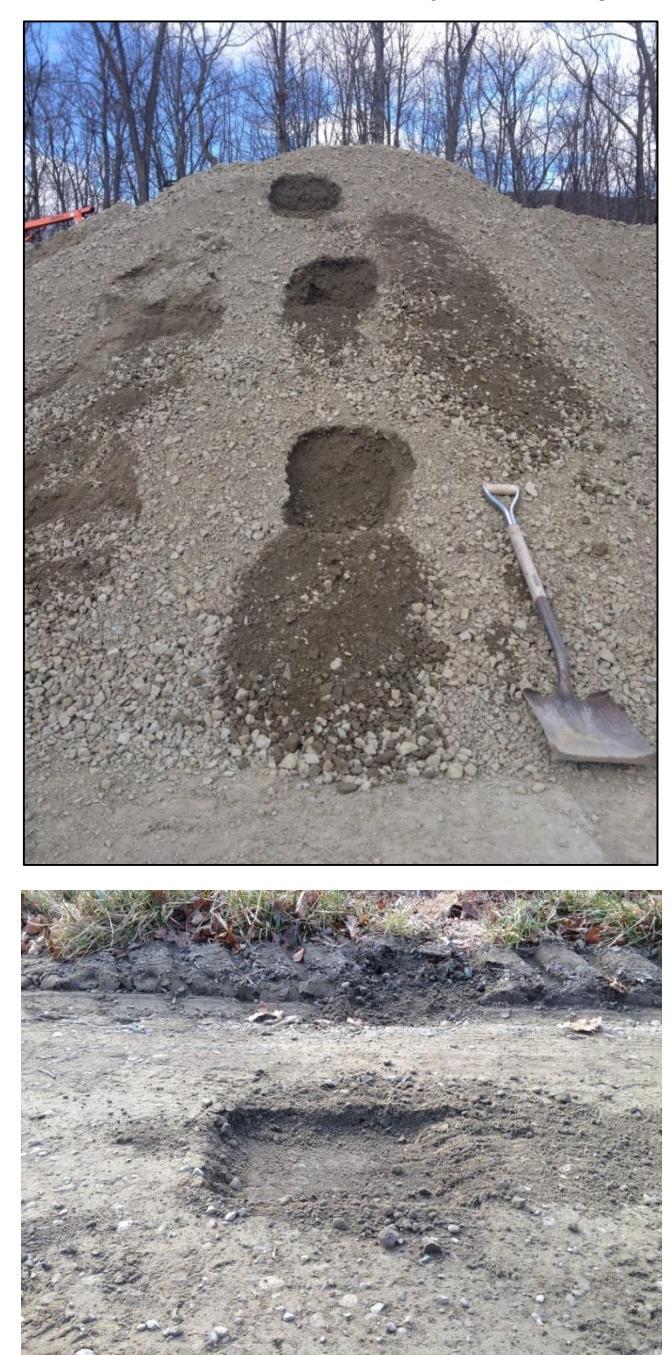
Photo of one sample location at the stockpile site.

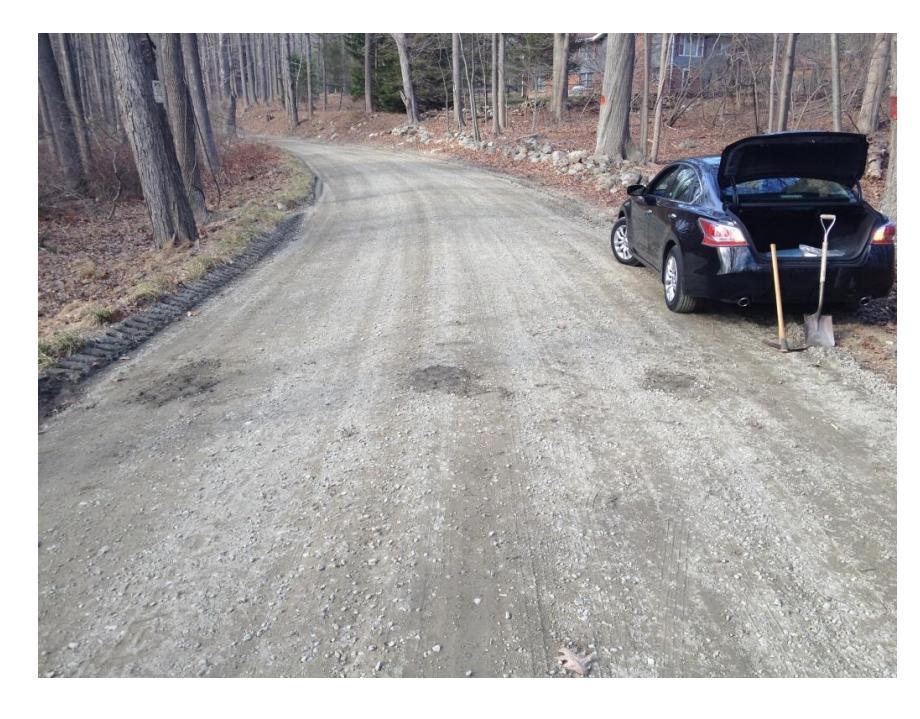
Example of coring or digging a test pit to obtain a road surface aggregate sample

The surface samples were obtained from the top three inches of the surface at three locations at each site. Test pits were cut at the center of roadway, and two feet from the edge of the traveled way on each side of the road.

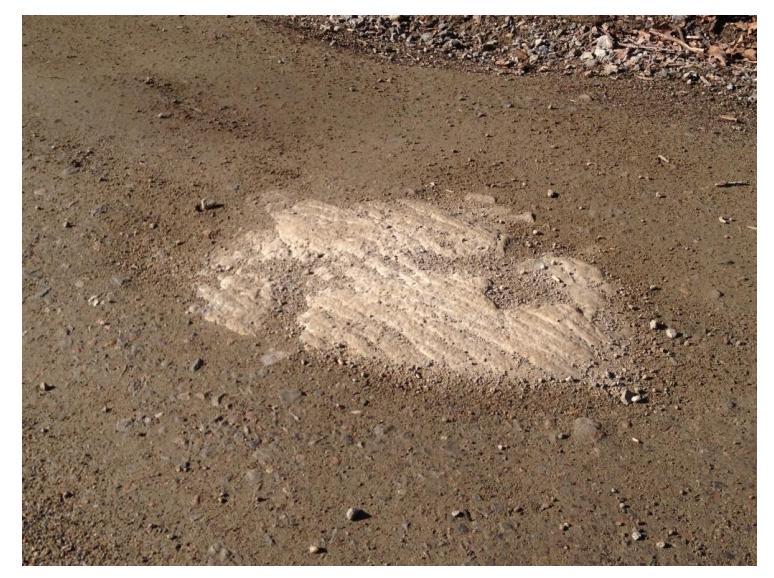
I have some concern about the quantity of material on the road. The layer thickness was adequate where the test pits were dug. However some areas of the roads show almost no material and traffic is essentially driving on the native soil.

Photo documentation of an area of the road with no surface aggregate indicated by native rock and soil showing at the surface.

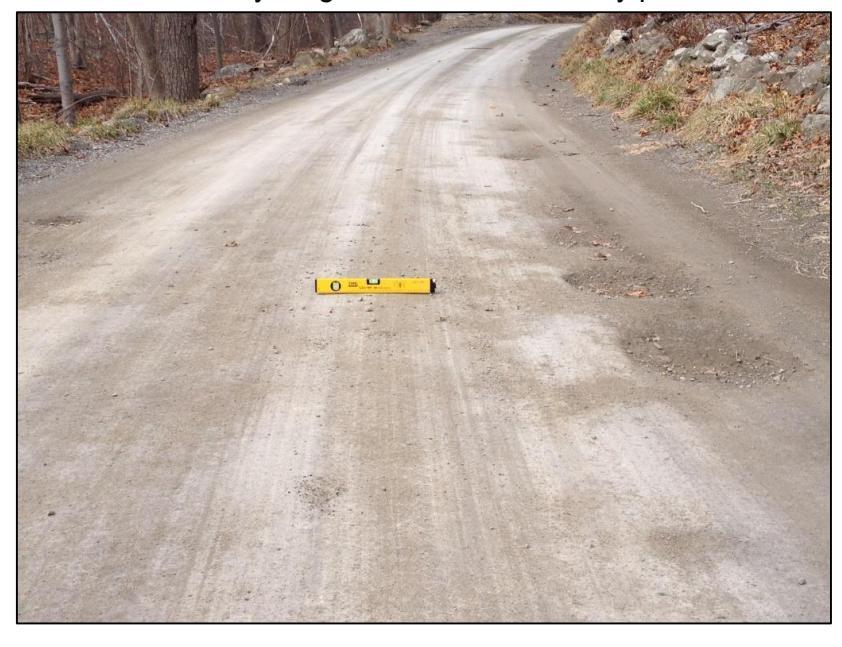
defined in the FHWA *Gravel Road Construction and Maintenance Guide*. A few locations have inadequate crown and potholes appear. That is a consequence of too little crown.

One area on the town road system that has less than 2% crown and potholes are present as a result.

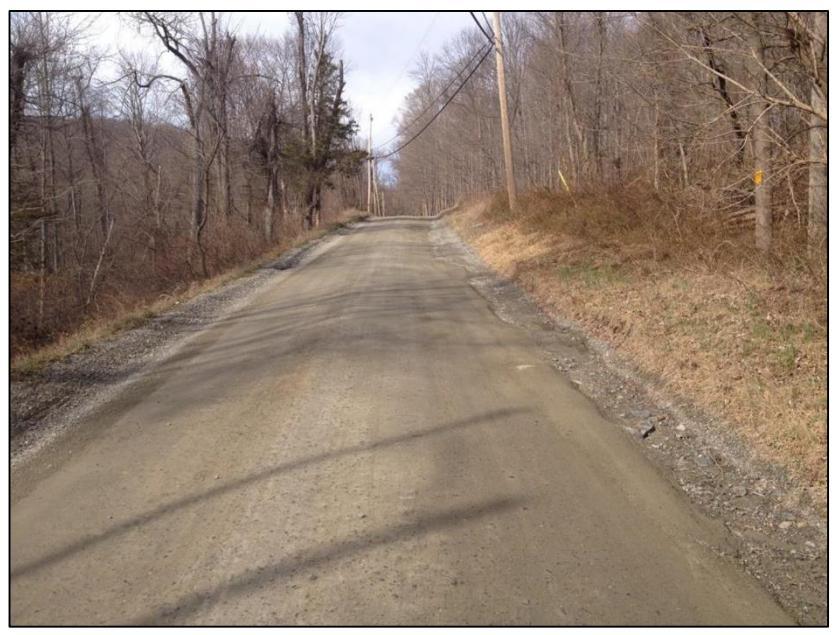
The bigger problem appears to be drainage at the edge of the roadway in a number of locations.

There is a lot of erosion shown here in which fine material in the ditch is eroding away when water flows along the edge of the roadway carrying soil with it. This needs a remedy

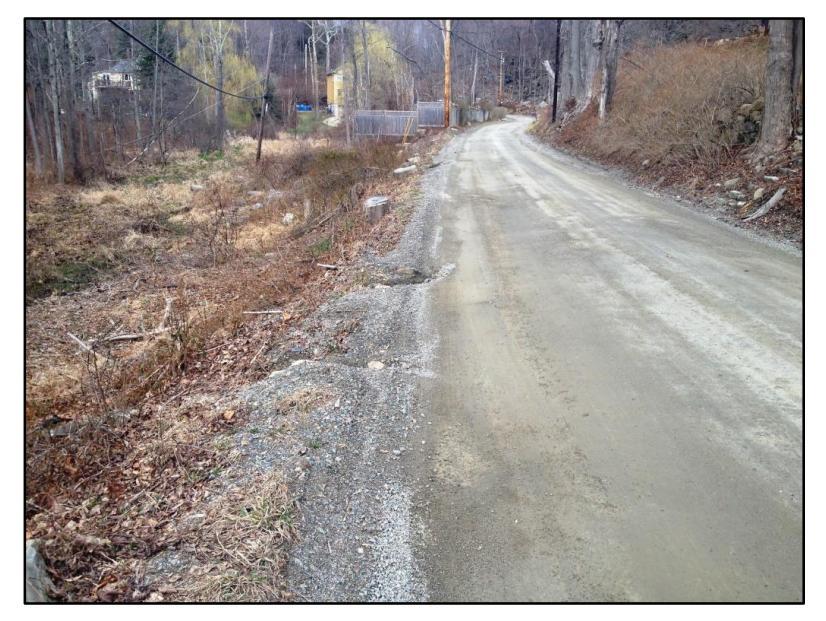
This photo at left shows a significant problem with a "berm" along the road in an area where the water could be drained off the shoulder along the entire section along the left side of the road. It is good to eliminate a berm anywhere it is possible.

It is also possible to "single slope" a road section like this and drain all of the water to the open (left edge as viewed here) side. That does require some significant reshaping of the road surface.

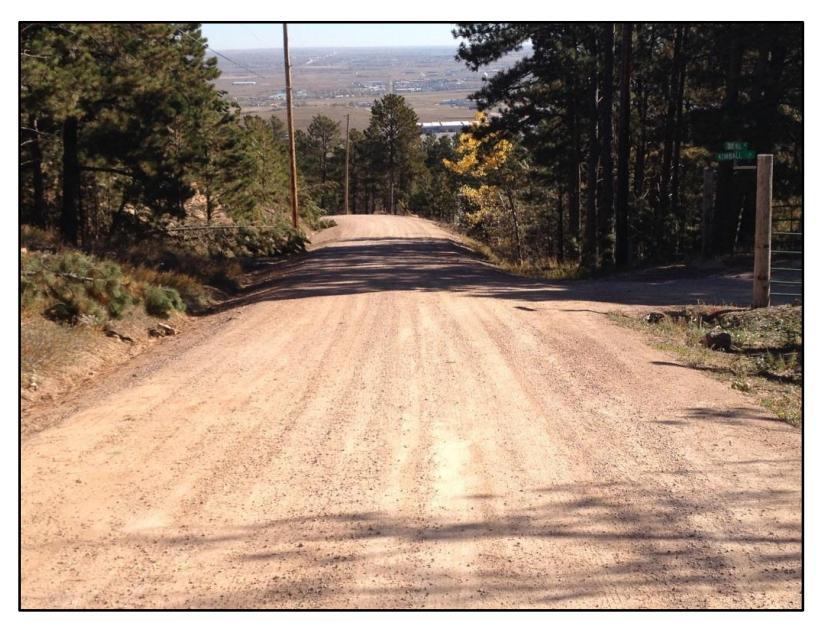
This photo is in another region of the country which receives overall less rainfall, but tends to get catastrophic rain/storm events. Note there is no berm along either side of the road surface. There is good drainage to a small ditch. Steepness of grade on parts of this road section approach 20% - not a good situation - yet the road performs quite well. It is due to two things: excellent shape on the road cross section and high quality surface aggregate that remains tightly bound and resists erosion and loosening under traffic

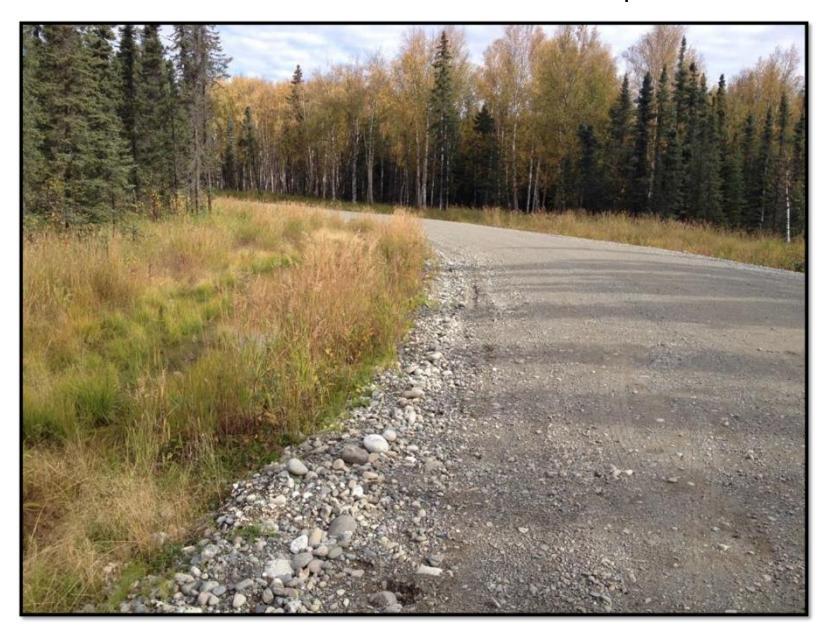
An example of a very simple rock-lined ditch to prevent erosion of soil along the edge of the roadway.

Here, native stone was used which is not crushed or processed in any way. It worked well here, but quarry stone that fractured will perform better in rugged terrain.

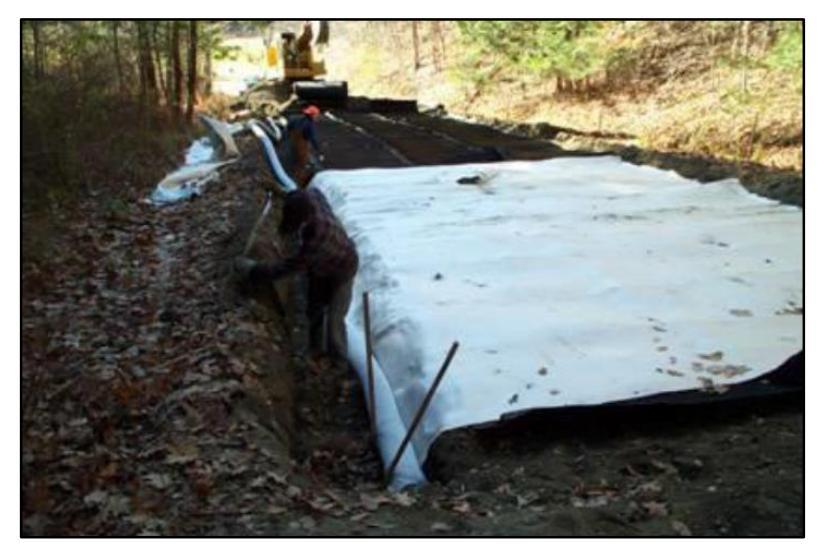
An example of a combination of a geotextile fabric being placed along with a drainage pipe and rock to be placed around it later.

Source: Figure 20. Geosynthetic capillary barrier drain (GCBD) installed on a test section over the subgrade/base interface in Vermont (Henry et al. 2005)

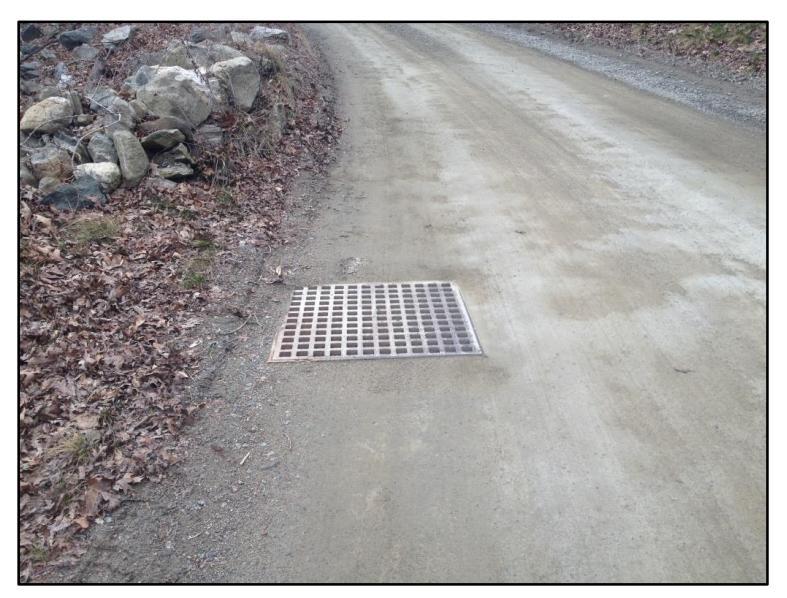
An inlet shown here on an unpaved Philipstown road. These can work if the surface material stays bound and does not erode into the drop inlet or catch basin.

However, they are always a challenge for motor grader operators when doing surface maintenance. It is hard to shape the road surface and not disturb the grate or move material into the catch basin.

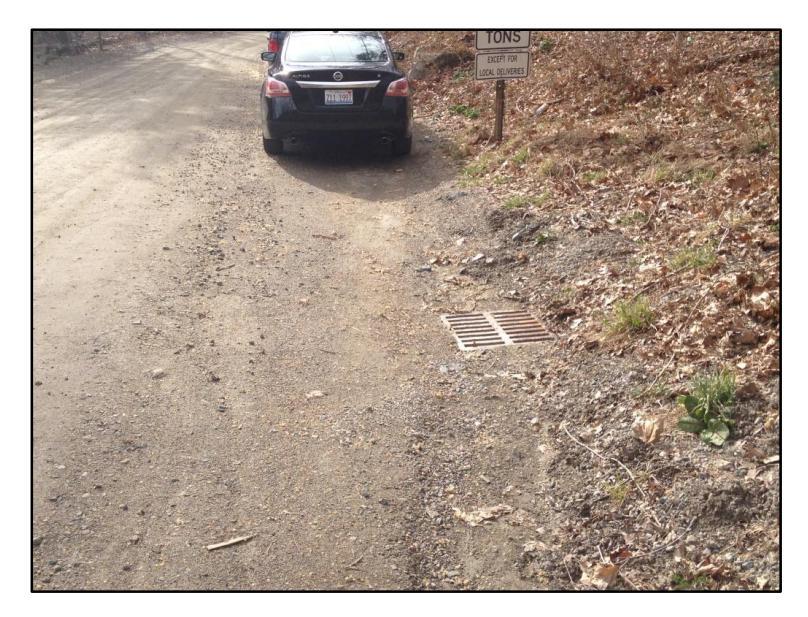
This is a better example of locating a catch basin outside of the traveled way and at a lower elevation allowing water to flow easily to it. It is also far easier for the motor grader operator to shape the road without disturbing the grate. Erosion control such as rock lining around the catch basin would be helpful to prevent soil from entering the basin.

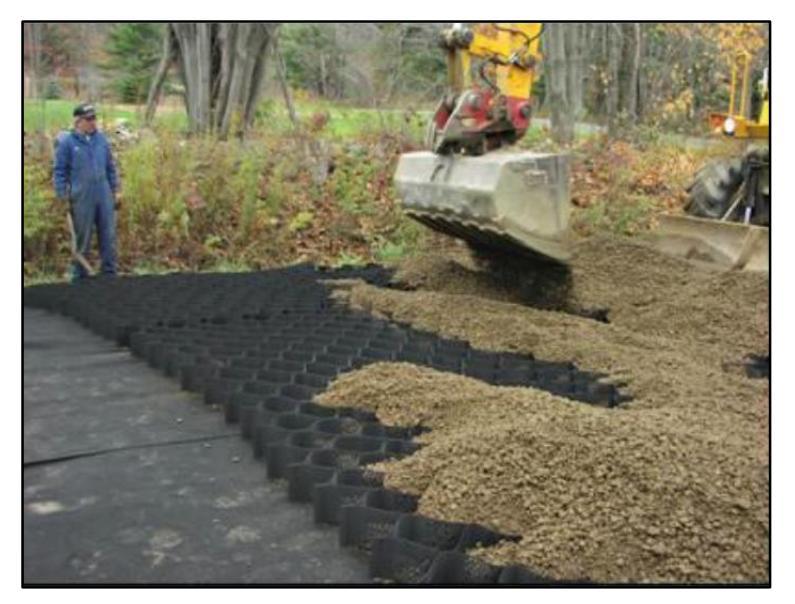
To further address erosion, here is an example of using good quality surface aggregate along with a geocell system placed on a geosynthetic fabric. This is not a highly technical process and when done correctly, it is an excellent way to virtually eliminate erosion problems in both surface and edge drainage along with drastic reduction in loss of aggregate and reduced blade maintenance.

Source: Figure 21. Geocells placed over non-woven geotextile on a test section in Vermont (Henry et al. 2005)

Quoting from Low-Cost Rural Surface Alternative, A draft study done by the Center for Earthworks Engineering Research at Iowa State University, pages 40 – 42: Geocells are another relatively new type of geosynthetics. Geocells are three-dimensional, honeycombshaped soil-reinforcing geosynthetics composed of polymeric materials and are primarily used for confinement of granular material (Figure 21 shown above). Geocells are placed at grade, infilled with granular material, and compacted. The cellular structures of the geocells provide lateral and vertical confinement and tensioned membrane effect, thereby increasing the bearing capacity and providing a wider stress distribution (Rea and Mitchell 1978). As a result, rutting or permanent deformations under traffic loading can be reduced. Typically, the geocellbase/subbase system is underlain by a geotextile to separate the infilled base/subbase material from the subgrade.

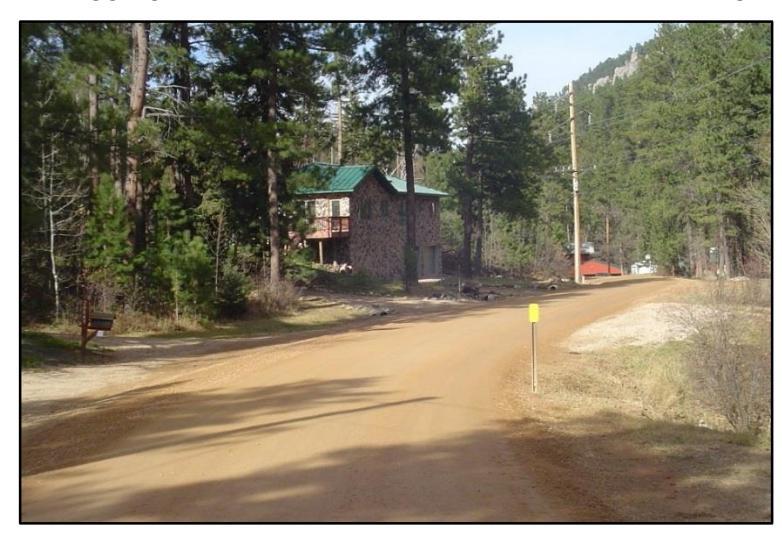
An example of a chloride treated road in a mountainous region that carries >1,000 vehicles per day (vpd) in the summer season and never carries less than 600 vpd in the winter.

This performance comes from excellent surface aggregate, good roadway preparation prior to treatment and good application of the chloride.

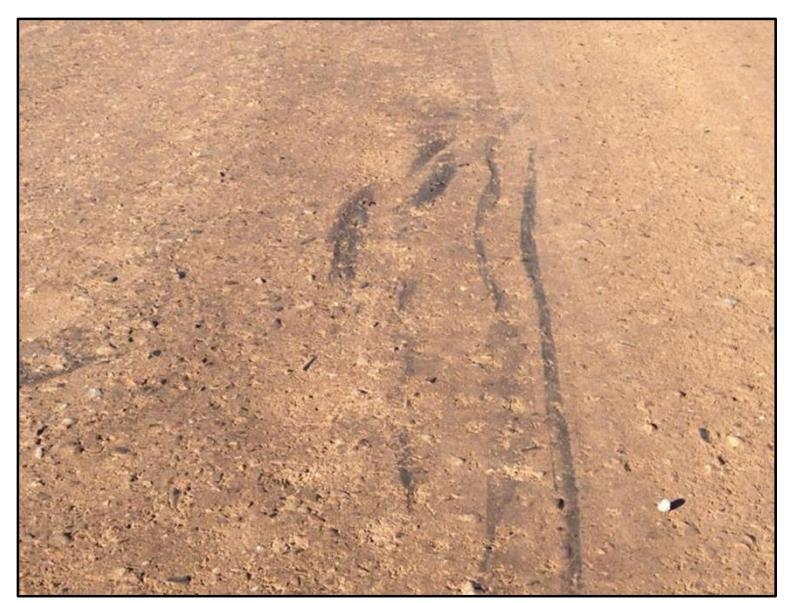
An example of outstanding surface performance on another road that carries just under 700 vehicles per day throughout the year. This includes over 100 heavy trucks per day.

Again, this performance comes from excellent surface aggregate, a chloride treatment along with good roadway preparation and product application.

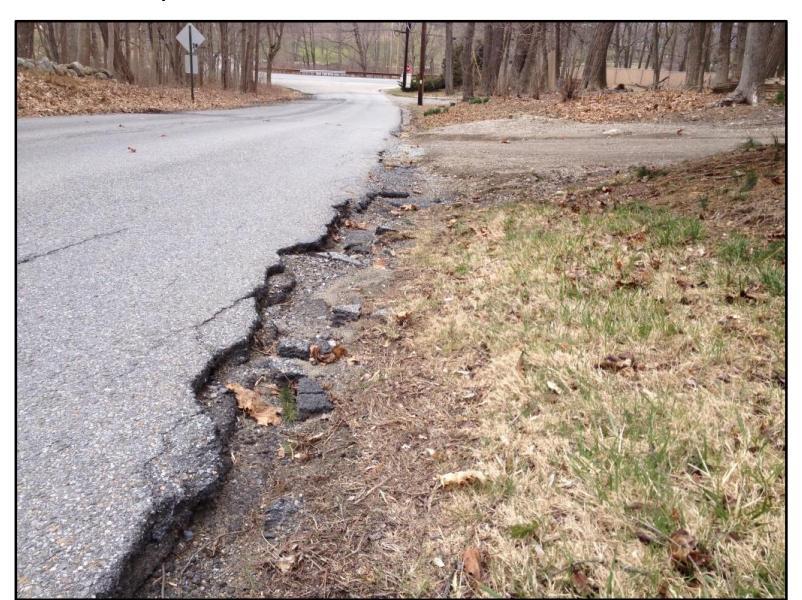
This is an illustration of erosion control and pavement edge repair needed on a Philipstown paved road.

Paving will not eliminate all of the problems that have to be addressed on unpaved roads. The performance on the two surface types differs, but maintenance always has to be done.

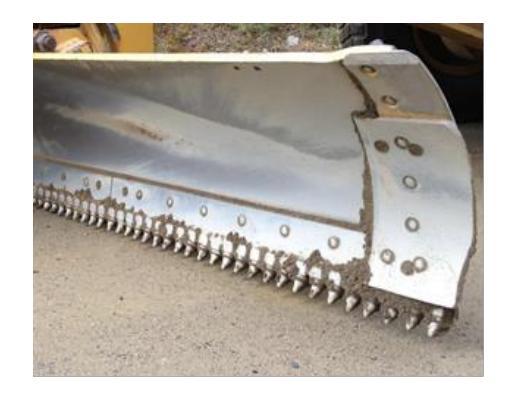
The road surface needs to be properly prepared before treatment. When stabilizing, loosen the top one to two inches of gravel. An ideal way to do this is to use a "bit type" cutting edge on the grader. These bits will have a shallow scarifying effect on the gravel and do a nice job of loosening the surface and blending the stone, sand and fines.

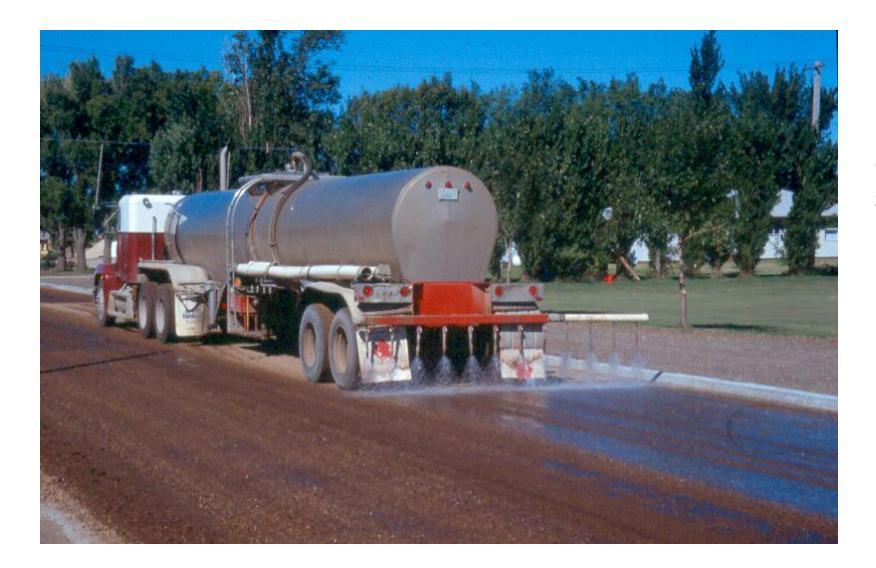
Excellent example of application of liquid chloride shown here.

Liquid chloride should be applied through a pressurized spray bar that gives a uniform application across the road surface. Also the truck's travel speed in feet per minute and the output of the spray bar in gallons per minute should be carefully calibrated so that a uniform application rate is made on the entire length and width of the road. Unless the rate of application is less than .3 gal per square yard, the product should be applied in two shots with ample time for absorption in between.
